**SLOPE STABILITY AT 'PENTIR', LLANBEDROG**

**Ecology and Arboriculture Report**

April 2018

3043/11/Ecology report

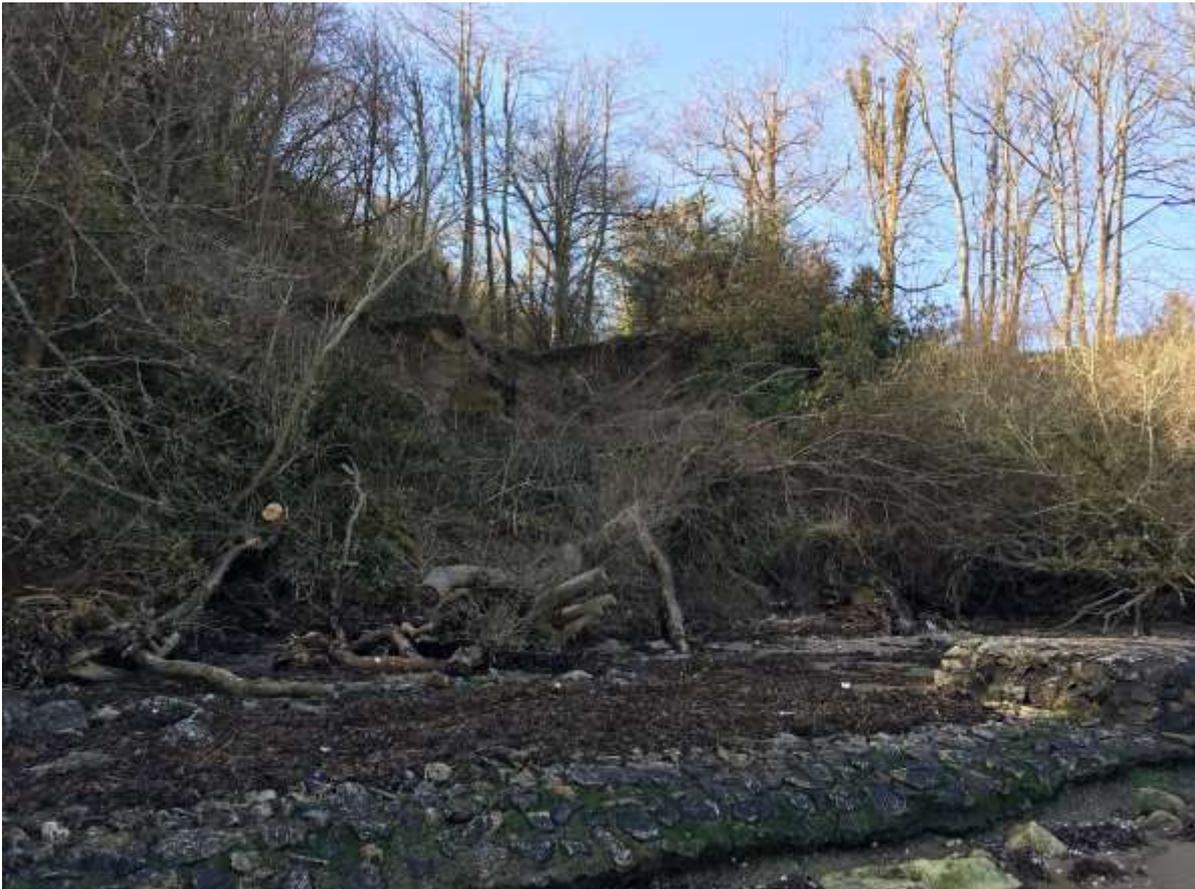
**Photograph 1- Eroded bank with fallen trees**

- 3.2.2 The habitat at the immediate top of the cliff, extending down towards the beach is best described as an area of natural woodland, although erosion of the cliff face has resulted in the majority of the trees having fallen over. A shrub layer composed mostly of rhododendron *Rhododendron x ponticum* still persists (See Appendix 1, Photograph 1).

- 4.4.1 The trees on the slope of the cliff have fallen, or are in the process of falling over as the soil erodes, with the majority of their roots exposed. It is likely that if no works were undertaken to the cliff these trees would be lost.

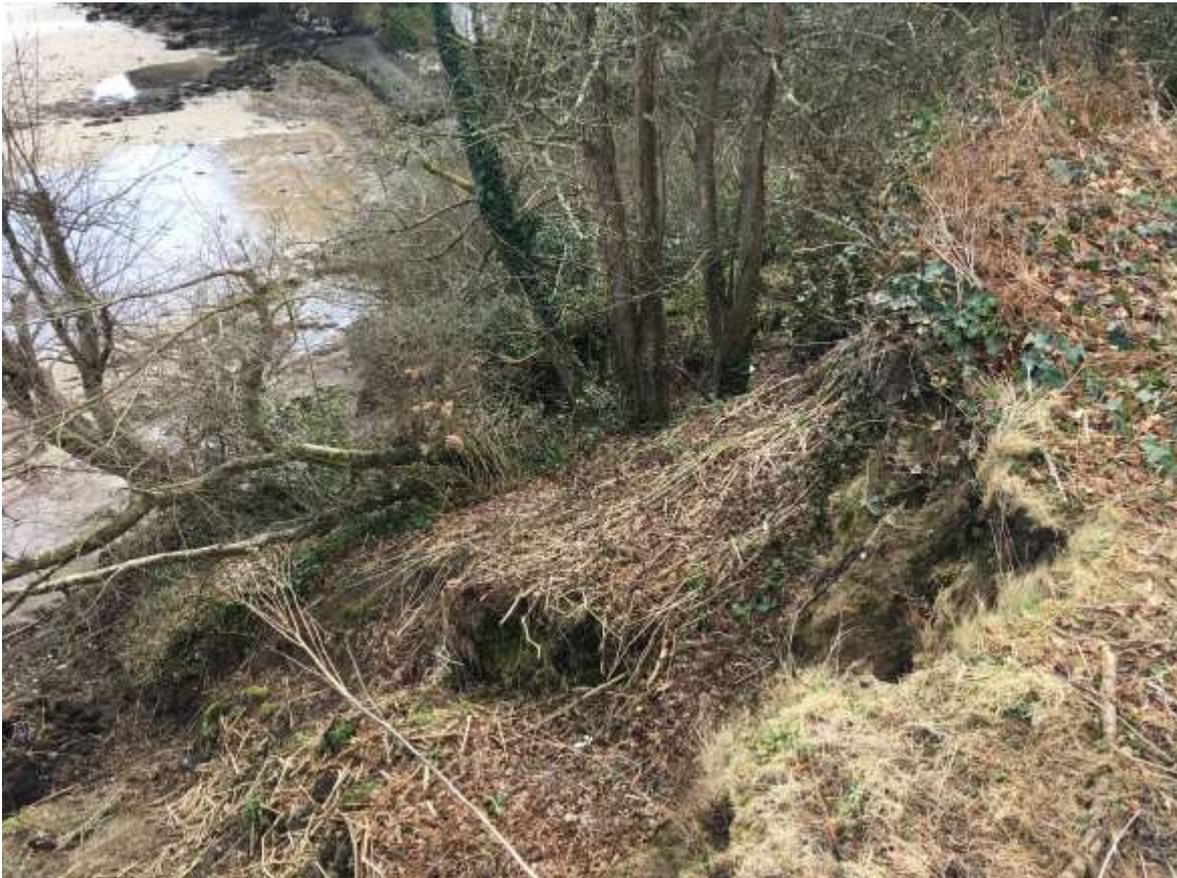
**Photograph 2- Dead stems of Himalayan balsam cover the majority of the collapsed slope**

- 3.2.4 The ground flora at the top of the cliff is dominated by common nettle *Urtica dioica* and the invasive plant species Himalayan Balsam *Impatiens glandulifera* (see Appendix 1, Photograph 2). It should be noted that owing to the time of year these plants were showing only limited signs of fresh growth (common nettle - new shoots and Himalayan balsam - newly germinating seeds) and the coverage of each plant was approximated based on the extensive amounts of dead stems that were present. A large area (approximately 3 x 4 m) is covered by a montbretia (see Appendix 1, Photograph 3). Through these plants are growing typical woodland species such as

- 4.5.2 Rhododendron and Himalayan balsam are spread by seed and both species are present in the wider area. Effective control of these species requires a landscape-scale approach, as any site-based control measures are unlikely to be effective. It is therefore not proposed to attempt eradication of these species within the site as part of the proposed works. However, measures will be implemented during construction works to prevent the spread of these plants. This will include storing soils in designated areas, replacing them within the works and ensuring all vehicles are jet-washed before leaving the site.

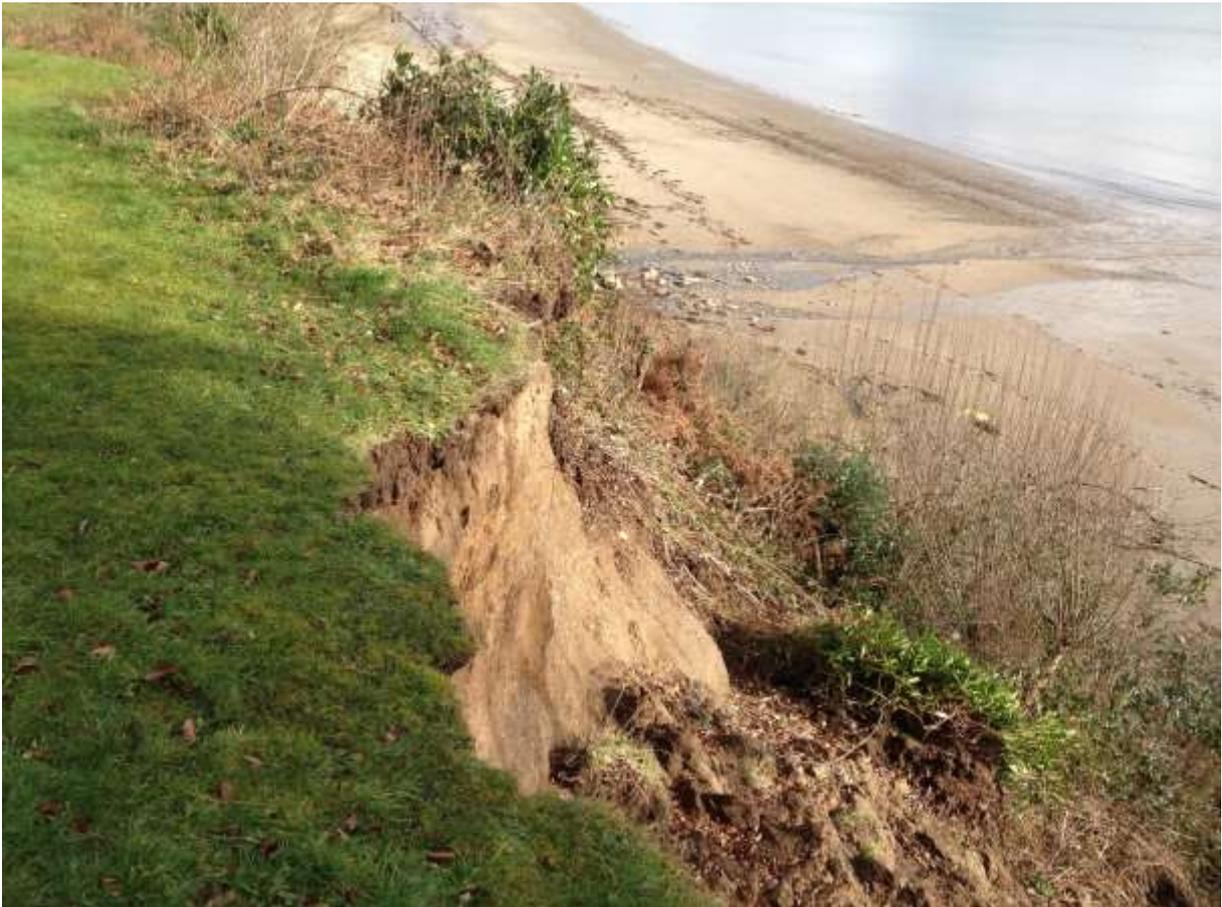
**Photograph 4 – Amenity grassland being lost to slope instability (February 2016)**

- 3.2.6 The land between the property Pentir and the woodland to the south consists of mown species-poor grassland in amenity use. This grassland extends to the top of the eroding slope and has in places been lost to this erosion (Photograph 4 in Appendix 1).

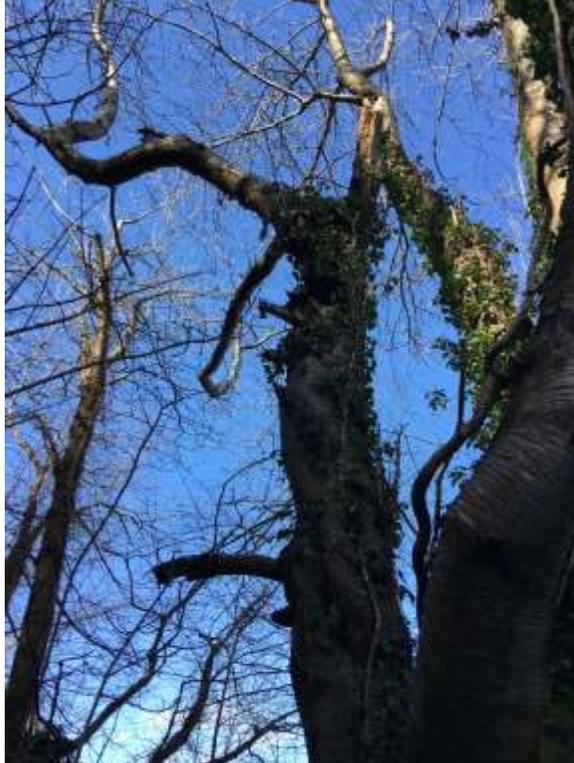
Tree number	Photograph	Details
T1

Mature cherry tree <i>Prunus avium</i> . Short trunk branching off at 1.5 m from ground level with rot in main branches
T2	(Not illustrated)	Mature beech <i>Fagus sylvatica</i>

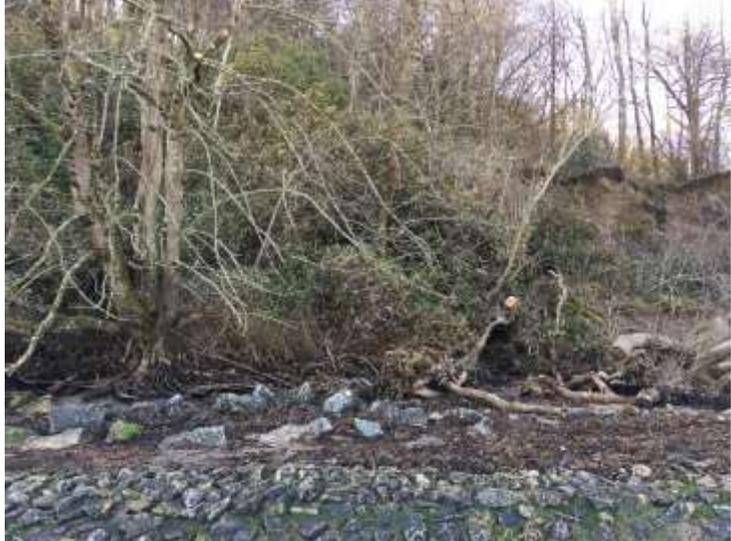
Tree number	Photograph	Details
T3

Semi-mature multi-stemmed sycamore with trunks cut at 3 m (shown to far left of photograph)
T4

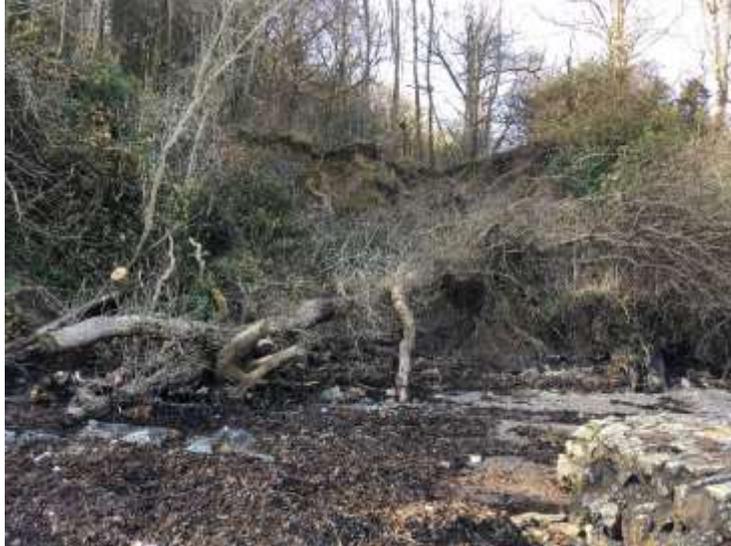
Semi-mature oak Quercus sp. Completely fallen over but still alive

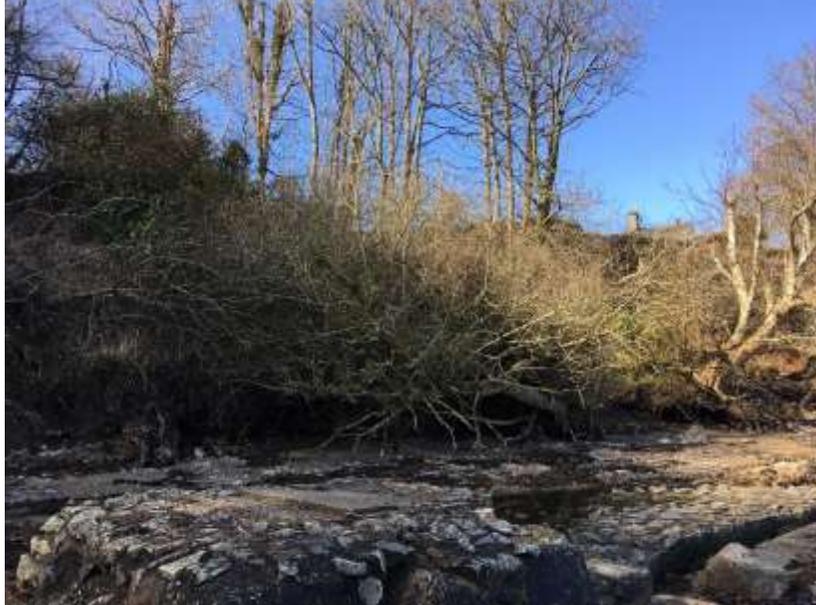
Tree number	Photograph	Details
T5

Mature sycamore. Completely fallen over but still alive. Roots exposed to sea

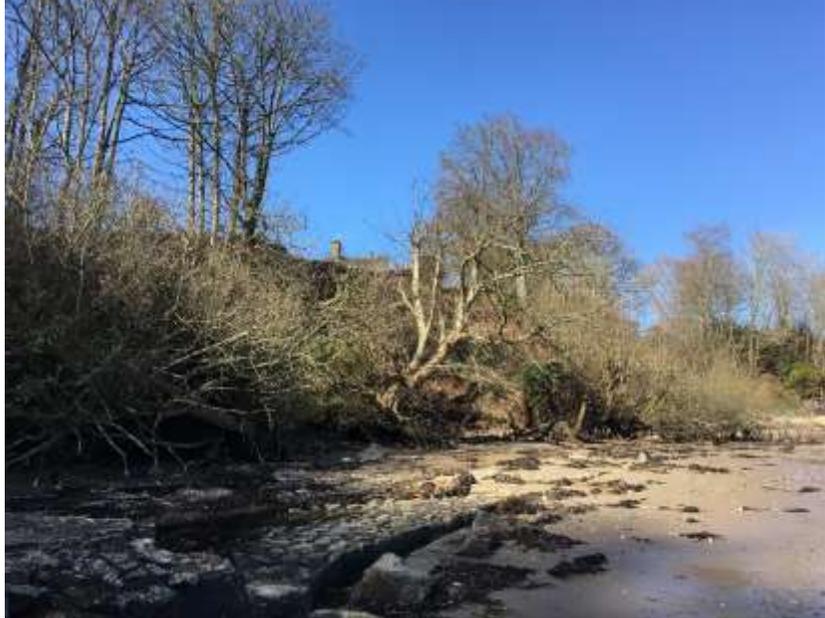
Tree number	Photograph	Details
T6

Mature sycamore. Leaning over cliff with root plate exposed and undermined. Likely to fall in the next year
T7		Semi-mature sycamore. Roots exposed and undermined
T8		Mature willow Salix sp. Roots exposed and undermined
T9		Semi-mature sycamore. Roots exposed and undermined

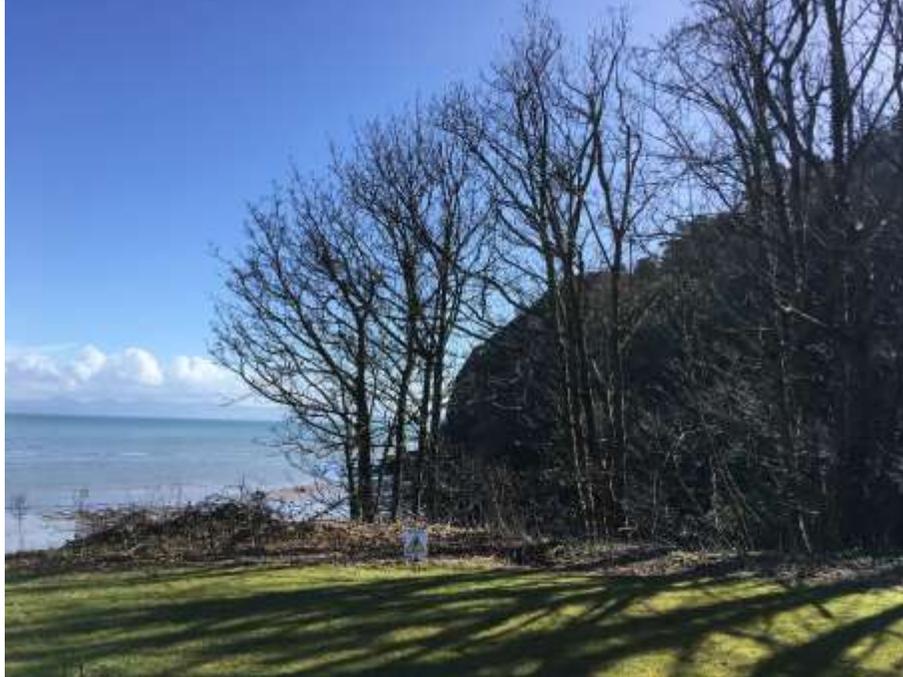
Tree number	Photograph	Details
Group 1

Numerous semi-mature multi-stemmed sycamore trees. Semi-mature cherry and holly Ilex aquifolium at top of cliff. No obvious signs of rot or disease.

- 4.4.2 The trees at the top of the cliff are mostly semi-mature sycamore and in reasonable health, with no obvious signs of decay. These trees provide some landscape value and it is considered that they can easily be replaced in the mid to long-term through the re-planting of tree species as discussed
